Zbigniew Siemiatkowski, Mirosław Rucki,
Dmitrij Morozow, Radom, Poland,
Robert Martynowski, Ostrowiec Świętokrzyski, Poland,
Alexander Shelkovoy, Yuriy Gutsalenko, Kharkiv, Ukraine

STUDY OF THE GEOMETRY OF GRINDING MACHINES USED FOR LARGE SCALE CRANKSHAFT MACHINING

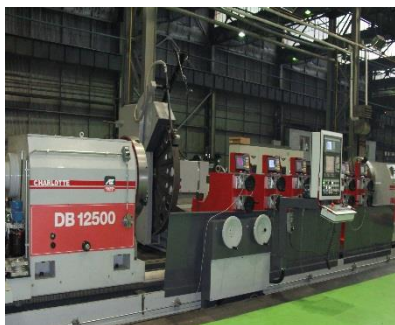
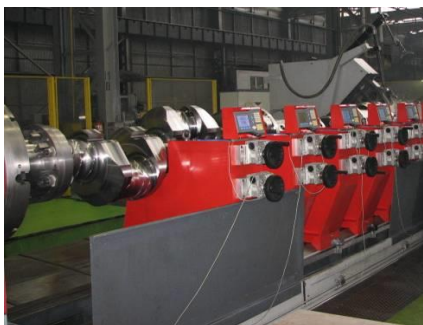
Figure 1 – The grinding machine DB12500 type:
(a) overall view; (b) the crankshaft ready for being grinded

Grinding is one of the final machining processes of the crankshaft fabrication. Main journals and cranks obtain the dimensions close to the upper tolerance, so that the surface can be finished by hand (lapping and polishing procedures). The examined grinding process was performed with a grinder DB12500 type (Figure 1) equipped with the control system Sinumerik 840D, measurement system MARPOSS and eccentric machining system PENDULUM.

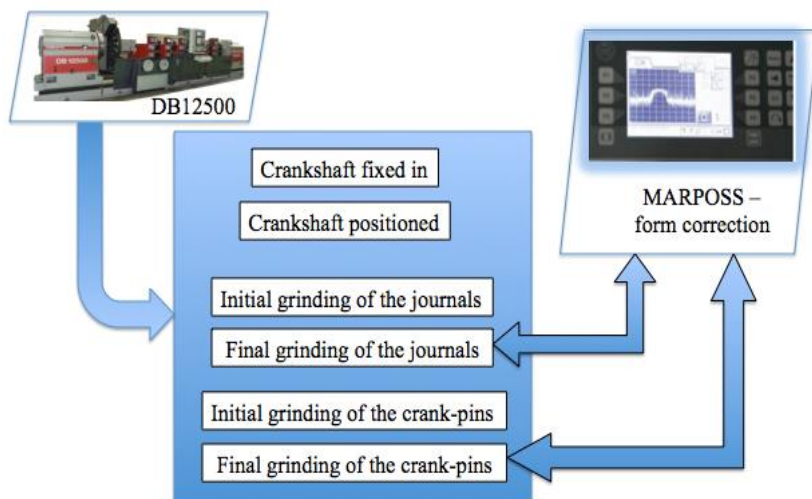
Figure 3 – Crankshaft grinding procedure

The above procedure is presented schematically in Figure 3. It is crucial that, after the initial grinding of all the main journals, MARPOSS device measurements are processed by and form corrections are performed, so that final grinding commences only after the main axis accuracy is assured.

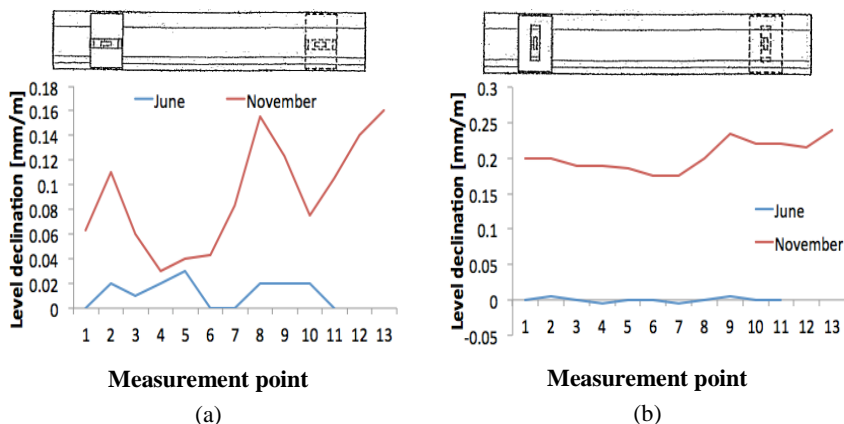
Figure 7 – Level check of the bed with fixed headstocks:
(a) parallel; (b) perpendicular

Figure 7 presents the results of level measurements obtained at different measuring points along the bed with fixed headstocks, in June and in November. The measurement was performed both in parallel and perpendicular directions.

The general observation is that after 5 months, the level deteriorated, so its regulation was needed to avoid the dimensional errors in the grinding process. Moreover, it is seen that the dispersion of the results is larger in the parallel direction (between 0 and 0.03 mm/m in June and between 0.03 and 0.16 mm/m in November) than in the perpendicular measurement (between -0.005 and 0.005 mm/m in June and between 0.175 and 0.24 mm/m in November). However, the dispersion of the respective results obtained both in the parallel and perpendicular directions was smaller in June than in November. It was concluded that the most instable level was the parallel direction, therefore it was recommended to check it more frequently, with the measurement taken at a minimum 3 points, to check for any trend.

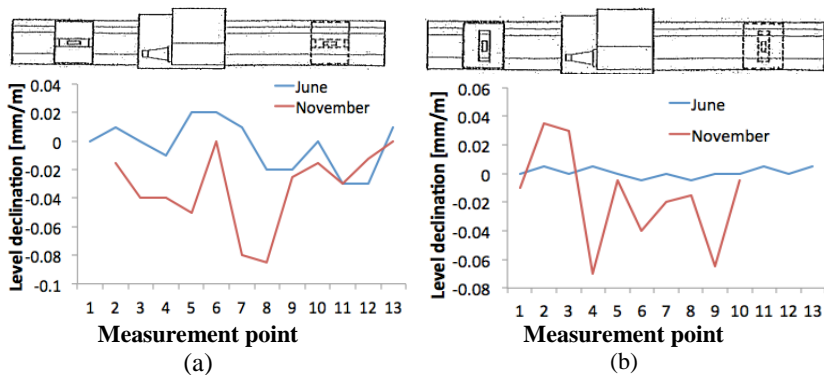
Figure 8 – Level check of the bed in the z axis:
(a) parallel; (b) perpendicular

Similarly, the bed level declination was checked along the z axis, both in the parallel and perpendicular directions. Figure 8 shows the positioning of the electronic level and the results of the measurement.

Again, the parallel direction displays a larger dispersion, particularly in the June measurements. The November measurement results are biased towards the negative values and are more dispersed than those of June. Thus, it can be recommended that the z -axis level is checked and corrected more often, and the measurement should be performed at all 13 measuring points.
